Rehabilitation of existing building structure in expansive soils: A case study in Laghouat, Algeria

Abstract. This work presents results obtained from a case study conducted on M'kam neighborhood (600 housing social city) in Laghouat, Algeria. The bloc (J) in this location, suffering from damages that are attributed to the expansive clayey soil interaction with sewage disposal under foundations was the subject of rehabilitation in this study. The principal causes of observed structural damages were studied through diagnostic expertise (inspection-evaluation process) of the cracks and sewage disposal system of bloc (J). The results of this diagnostic investigation show that the main damages were mainly due to swelling of soil in presence of losses from sewage disposal. Remedial actions were suggested to revise and repair all the sewage disposal system and strengthen the foundations of the building to avoid further damages.

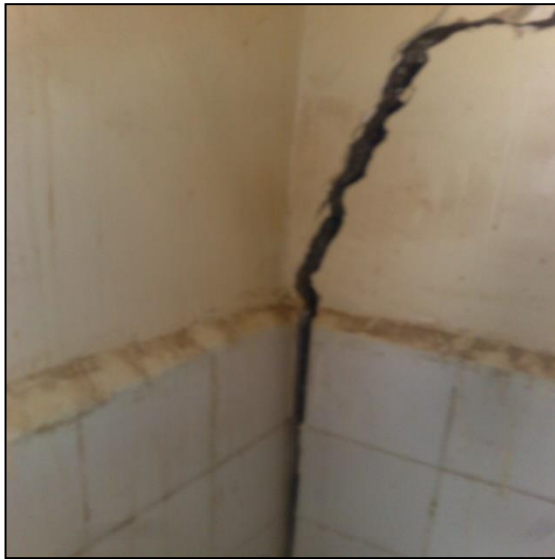
a) Inside

The bloc (J) consists of sanitary basement, ground commercial floor and three floors for residential use as shown in Figure 2. The visual inspection of the structure revealed evidence of cracking of external and internal walls of first and second floors. Some photographs showing the current state of cracks inside and outside bloc (J) building are presented in Figure 3. Most of the cracks in the building were found to be at the internal walls of first and second floors.

Fig 3. State of cracks inside and outside bloc (J) building.

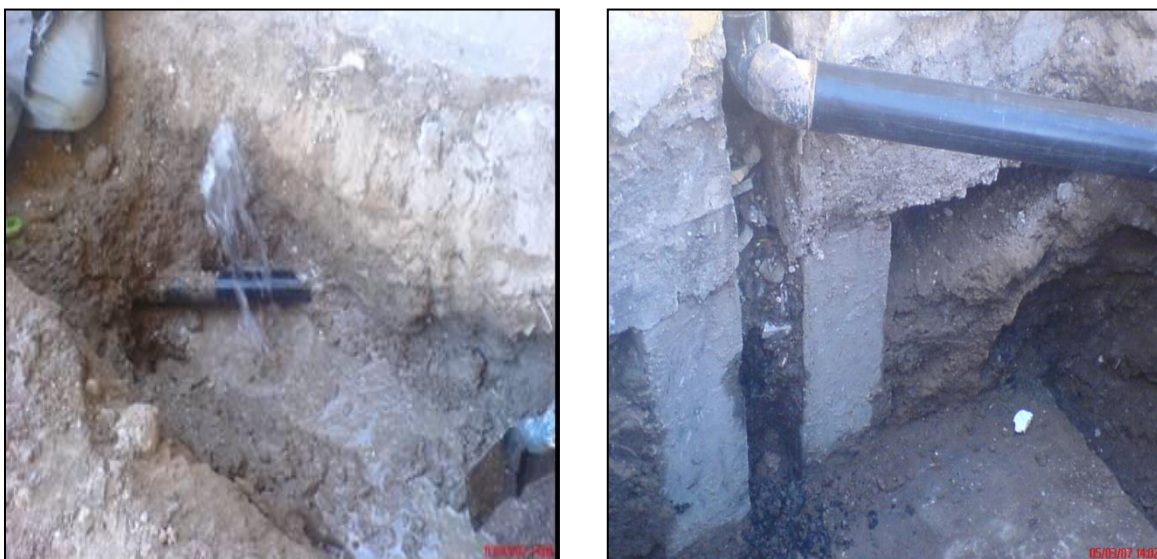
The main sanitary sewer system of the building is located in the basement and collects wastewater from the floors sewers. Blockages in the building sewer can cause backups of sewage toilets, showers and floor drains. These types of blockages are sometimes referred to as basement backups, which can lead to disease, destruction of valuables and damage of building property. Damages in the building sewers system have been located in the basement of the studied building, which causes infiltration of wastewater through cracked pipes (Figure 5).

Fig 5. Infiltration of wastewater through cracked pipes.

The first step to repair the damages is repairing building sewers. The solution consist on performing an inspection of wastewater utility, prior any repair, to identify if there is a problem in floors sanitary sewer pipe system. After this preliminary inspection, the main sewer manhole located in the interior of building (in basement) is changed to the exterior, before the main sanitary sewer in the street, to avoid any wastewater infiltrations around the foundations (Figure 6).

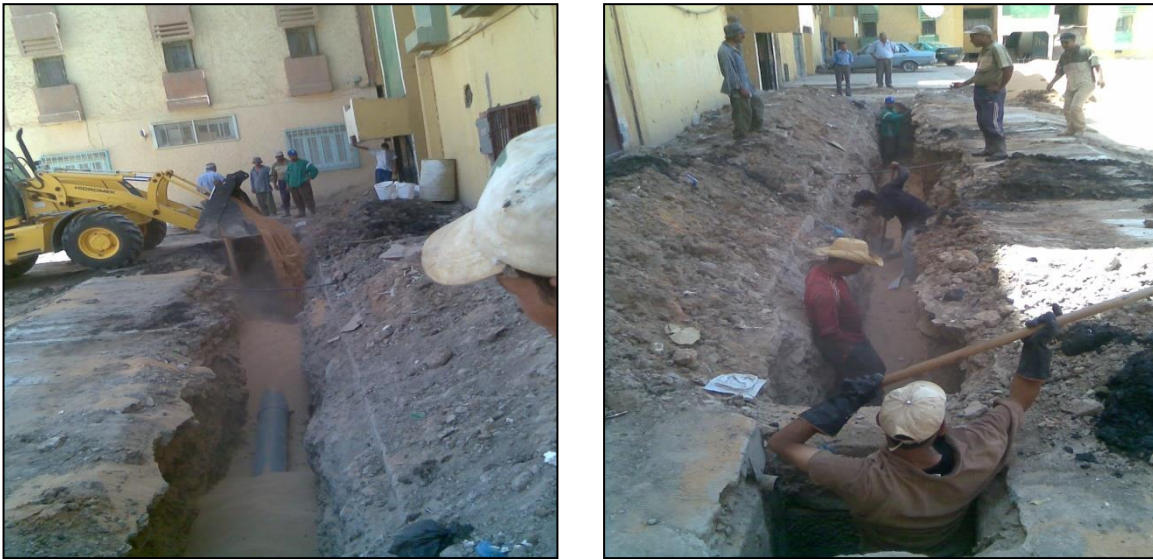
Fig 6. Main manhole sewers were moved completely outside the building.
