# Corrosion evaluation of glass fiber reinforced plastic (gfrp) Tanks & pressure vessels using acoustic emission technology

### ABSTRACT

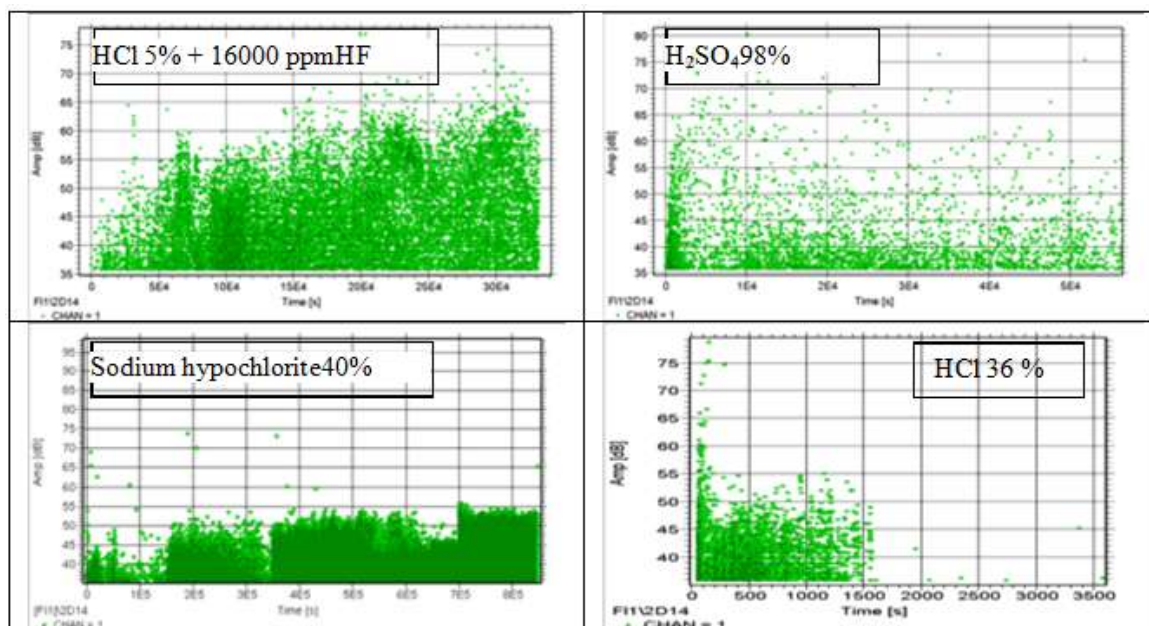
Figure 2. Different acoustic emission activity due to different aggressive environments

We see on the figure 2 that the different environments will create different acoustic emission activity.

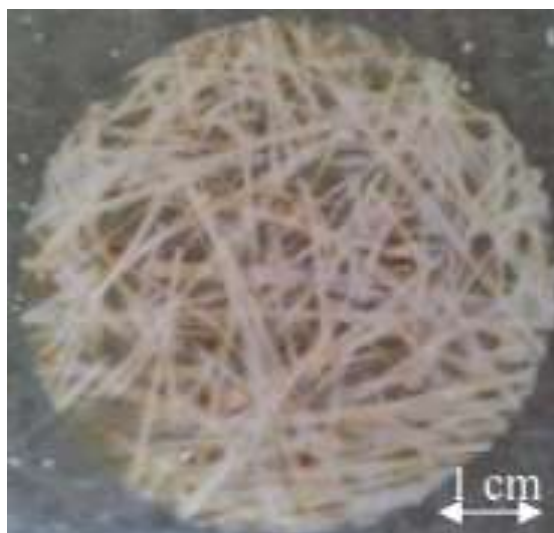
Figure 3. Picture of consequences of the corrosion on GFRP

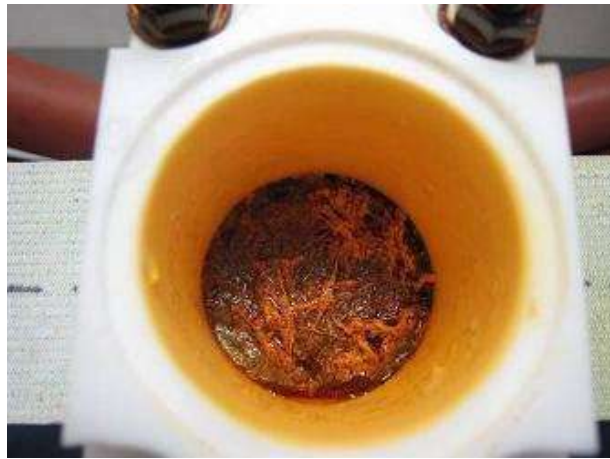
Figure 11. GFRP specimen after corrosion test with bromine.

Corrosion tests were performed on GFRP specimen in contact with bromine, monitored with 2 AE sensors. The dimensions of the specimen are 50 x 300 mm, cut from a healthy area of the dissected tank. The PVDF layer is removed from the specimen. No surface treatment is done (the synthetic fiber fabric is still present). Figure 11 shows the specimen after the corrosion test.
