Rehabilitation of existing building structure in expansive soils: A case study in Laghouat, Algeria

Abstract. This work presents results obtained from a case study conducted on M'kam neighborhood (600 housing social city) in Laghouat, Algeria. The bloc (J) in this location, suffering from damages that are attributed to the expansive clayey soil interaction with sewage disposal under foundations was the subject of rehabilitation in this study. The principal causes of observed structural damages were studied through diagnostic expertise (inspection-evaluation process) of the cracks and sewage disposal system of bloc (J). The results of this diagnostic investigation show that the main damages were mainly due to swelling of soil in presence of losses from sewage disposal. Remedial actions were suggested to revise and repair all the sewage disposal system and strengthen the foundations of the building to avoid further damages.

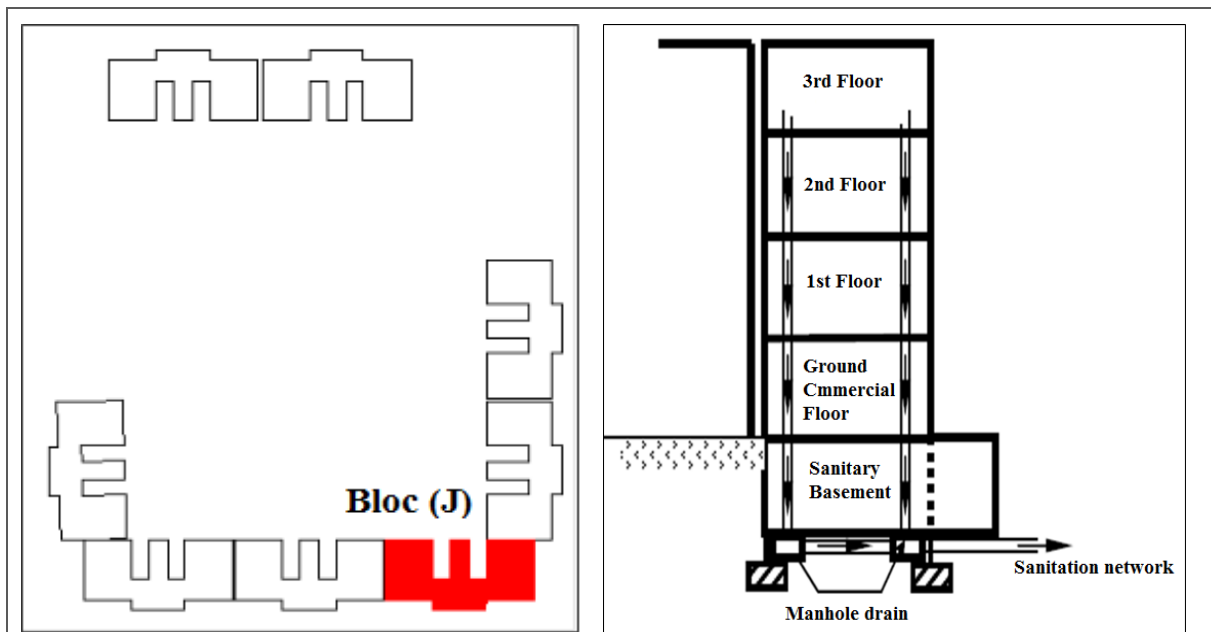
Fig 2. Situation and general structure of Bloc (J) building.

The bloc (J) consists of sanitary basement, ground commercial floor and three floors for residential use as shown in Figure 2. The visual inspection of the structure revealed evidence of cracking of external and internal walls of first and second floors. Some photographs showing the current state of cracks inside and outside bloc (J) building are presented in Figure 3. Most of the cracks in the building were found to be at the internal walls of first and second floors.

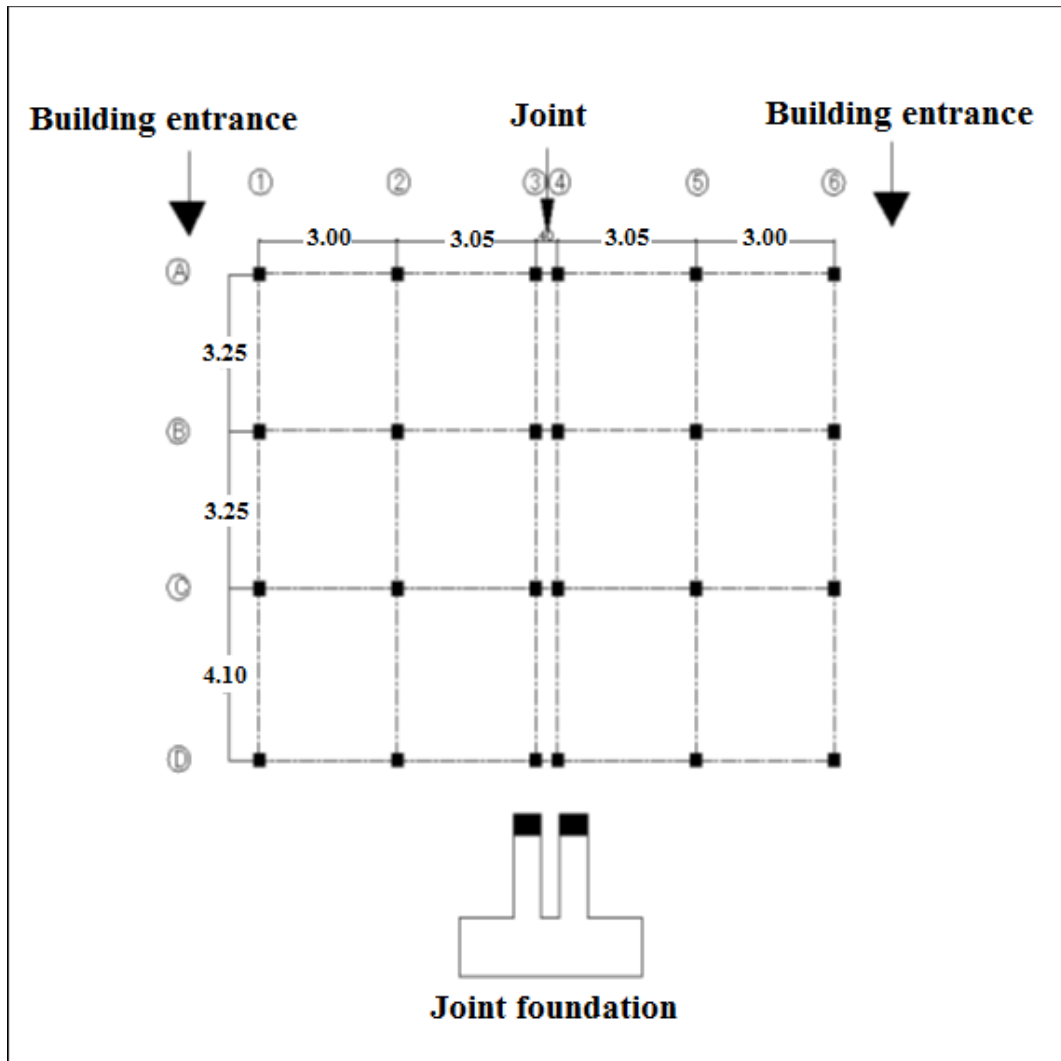
Fig 4. Foundation plan of the building.

The foundation of the studied building is of the superficial type, it is formed of insulated soles bonded by stringers. These soles are placed on a massive concrete. The foundation plan of the studied building is presented in Figure 4.

stability of the building and to correct the expansion joint openings caused by the differential movement of the foundations, reinforced concrete footings with peripheral sails were installed on both sides of each expansion joint along the total building basement height (Figure 7).
