Surface Characteristics Analysis and Adherence Evaluation of Hot-Dip Galvanized Low Alloy Steel

Lamia Darsouni^{*1}, Mohamed Zine Touhami¹, Abdelkader Khettache² & Omar Benchiheb¹

¹Foundry Laboratory, Department of Metallurgy, Badji-Mokhtar University, PO Box 12, 23000, Annaba, Algeria.

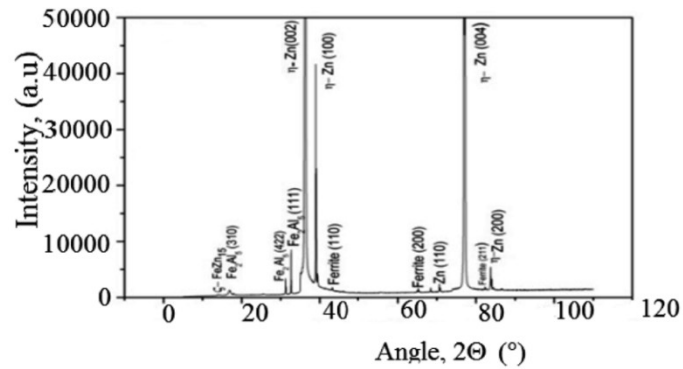
Figure 4. X-ray diffraction spectrum of A9 steel hot-dip galvanized

a) Grazing angle diffraction ($\omega=1^\circ$). In our case, the introduction of low Al content (0.5 wt%) added to the Zn bath prevent the formation of the Fe-Zn intermetallic phases by the formation of an inhibition layer [16]. The minimum amount of Al needed for the full inhibition is around 0.15 wt% at 450°C [16]. According to the Tang N.Y. [18] study, the inhibition layers form in two steps involving (a) an Al uptake and subsequent nucleation of $\text{Fe}_2\text{Al}_5\text{Zn}_x$ layer at the substrate interface, and (b) the growth of the inhibition layer by the diffusion of Zn atoms across the layer. The $\text{Fe}_2\text{Al}_5\text{Zn}_x$ inhibition layer has a fine granular structure and an orthorhombic structure with around 23 wt% Zn [16]. The intermetallic phases constituted by one layer called inhibition layer is very thin (from 50 to 150nm) is characterized by a hardness and non acceptable toughness [19]. The inhibition layer will be thin and, consequently, more iron (Fe) will diffuse into the liquid zinc to form Fe-Zn compounds.

The coating microstructure of a sample galvanized for 4s is shown in Fig.5. It was found for all specimens hot dip galvanized have the same phases confirmed by X-ray diffraction analysis Figs.4 and 6 such as Γ - Fe_2Al_5 ($\text{Fe}_2\text{Al}_5\text{-Zn}_x$), and $\text{Fe}_{11}\text{Zn}_{40}$ phases next to the steel substrate, and FeAl_3 ($\text{FeAl}_3\text{-Zn}_x$) phase next to coating surface [15]. In reality, the reactions occurring in a galvanizing system and mechanisms controlling the nucleation and growth of Fe-Zn intermetallic phases are very complex due to the addition of different elements mostly Al into the Zn bath (0.5 wt.%), impurities in the ferrous substrate, coincidence of different reactions at the interface, their fast kinetics and non-equilibrium conditions governing the process [17].

X-ray diffraction results show (Fig.4) using glancing angle diffraction ($\omega = 1^\circ$), the presence of interface layer (Γ - Fe_2Al_5) between substrate and zinc coating. Other hand, it is constated also, for a small glancing angle diffraction ($\omega=0.001^\circ$) for all samples with different thickness (Fig.6a-c), the formation in contact directly to substrate, the same phase Γ - Fe_2Al_5 .

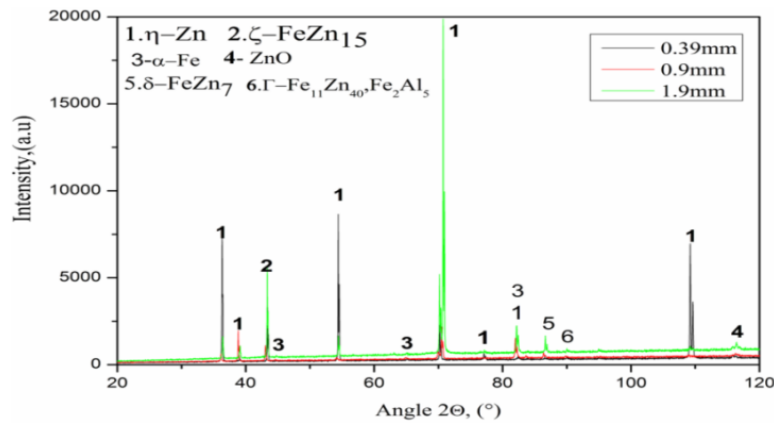
Figure 6. X- ray diffraction spectrum of A9 steel hot- dip galvanized
 b) Grazing angle diffraction ($\omega=0.001^\circ$),

Direct contact between zinc melt and steel is now avoided and the growth of Γ phase is prevented. Others layers appeared such as δ -FeZn₇, ζ -FeZn₁₅, η -Zn and ZnO in extremely surface. These compounds, usually ζ -FeZn₁₅, nucleate on top of the inhibition layer. Hence, Fe diffuses from the steel substrate into the zinc bath through the solid inhibition layer.

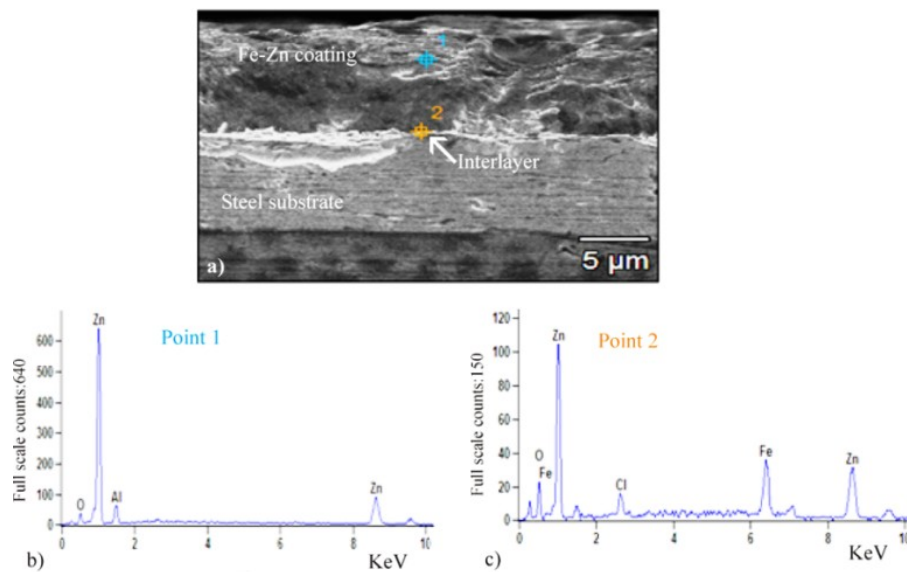
Figure. 8 (a,b,c). a) SEM micrograph b) and c) EDX analysis on cross section of A9 steel hot dip galvanized.

Ferritization phenomenon of the surfaces greatly improves the adhesion of Fe-Zinc layers to the steel substrate and mainly for the thin and medium plates. EDX analyzes on cross sections of the galvanized samples showed the presence of oxygen on the substrate-coating bond interface; which amply justifies the formation of a thin film of iron oxides which can play an important role in blocking the zinc diffusion on substrate (Figs.8a-c).
